Manhole Inspection Summary

Manhole # S19QQ_012MH

Insp Date: **7/10/07 11:17 AM**

Location Address: **3501 WOODBROOK**

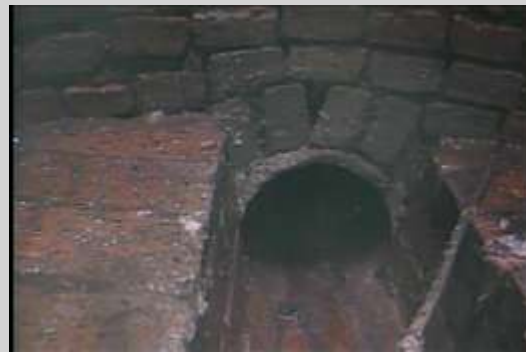
12 O'Clock Outflow
Pipe Out @ 12 O'Clock

Pipe Height: **8.4** (in.) Rod and Bar (Angled)
Pipe Material: **Clay** ☐ Pipe Lined
Invert Depth: **5.62** (ft.) Flow Characteristics: **Slow**
Deposits: ☒ None ☐ Mud ☐ Sludge ☐ Debris ☐ Grease
Silt Depth: (in.) Deposits Extent:
Infiltration: **None** Pipe Seal Cond: **Broken**

Drop: **Outside** Rod and Bar
Angled: **Yes** Reading: **8.31** (ft.)
Inv Depth: **9.31** (ft.)
Drop Condition: **Partly Clogged**
